1214 BARRY LINE ROAD

WEST GUILFORD

Information Package

PERSPECTIVE SUMMARY

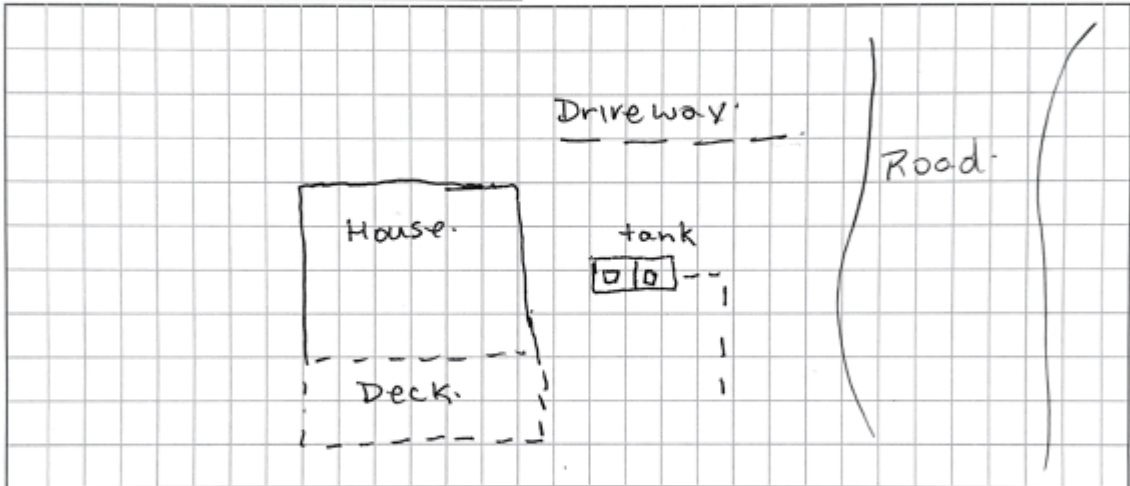
SKETCH AREA - LAYOUT OF SEPTIC SYSTEM

AT THE TIME OF THE INSPECTION THE SEPTIC TANK IS FREE OF STRUCTURAL DAMAGE & OPERATING AS INTENDED: YES NO

Next pump out 2026+-
